# Repairing the Tank Cap of Honda CX Turbo models

By Joe Hovel © 2014

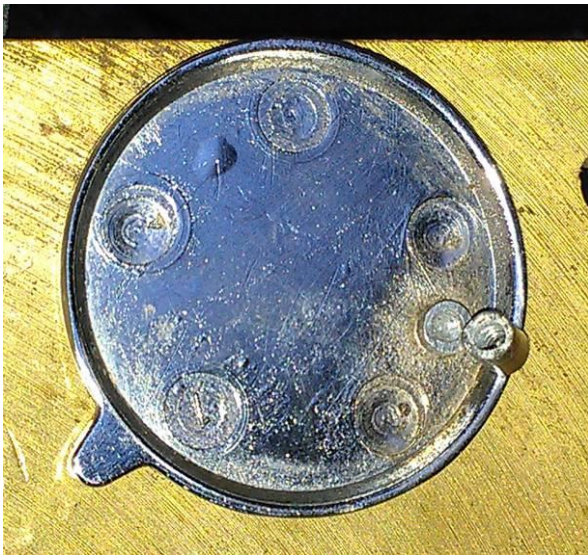
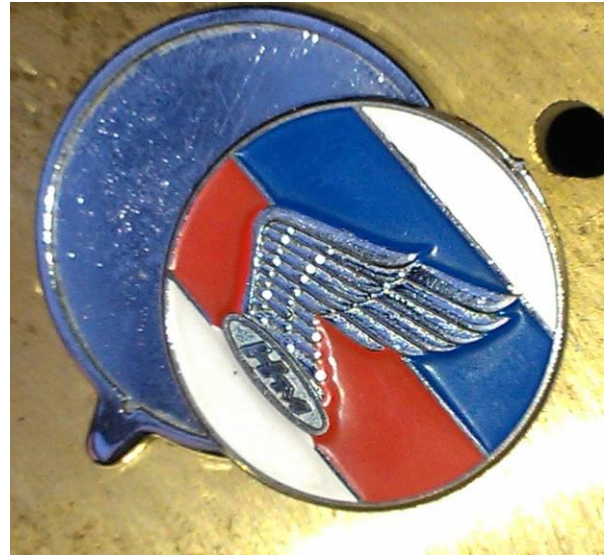
This is the typical damage sustained by the lock swing cover: the little die-cast peg which holds everything together breaks off. Fortunately, the little spring, collar and screw remain inside the diecast body. See next page.

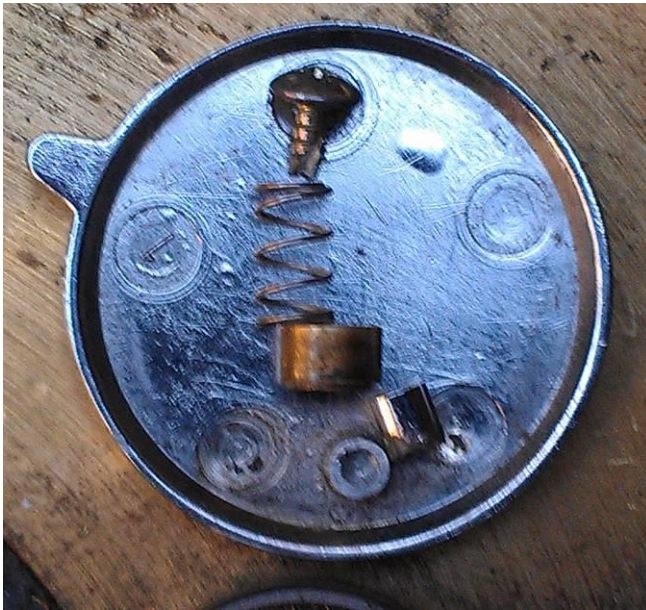
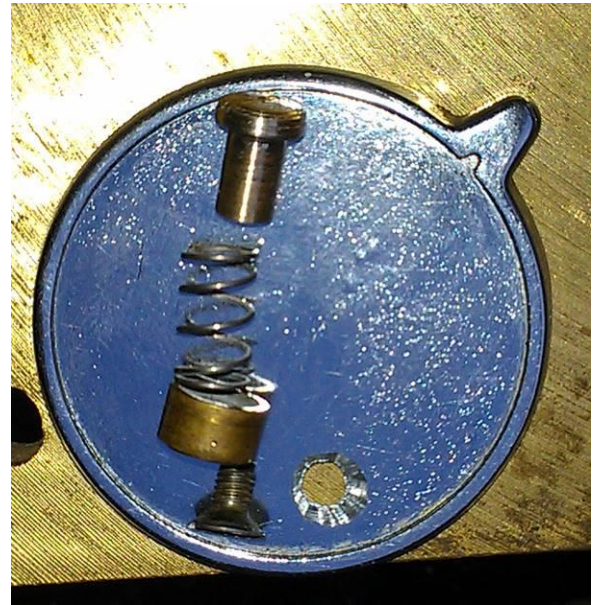
The left picture shows the original broken swing and spring mechanism and the right photo shows the replacements.

The remaining dimple of the original spring post can be used to drill through the diecast swing lid in exactly the right spot. Any remaining protrusion is then filed or scraped off and the hole countersunk to match the head of a new M3 screw.

The other new part required is female panhead screw, internally tapped M3. These are not generally available but can be made using a suitably shaped M5 brass screw or bolt in a small lathe.
